Town of Arlington

DRAFT REPORT

ADA Self-Evaluation (as basis for Transition Plan)

Prepared by
Institute for Human Centered Design
September 15, 2014

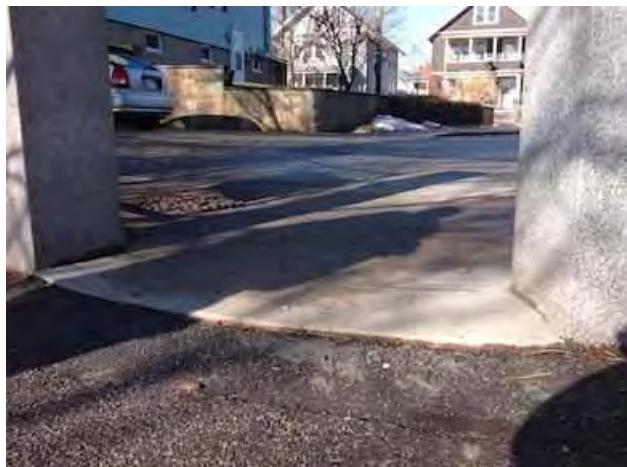
Photo 2

Curb ramps at Intersections near the Teel St. entrances do not connect with accessible sidewalks, have steep slopes and are missing level landings. New curb ramps at the Waldo Road/ Amsden intersection are incorrectly constructed as apex instead of perpendicular and lead users into road instead of along sidewalk route. (Photo 2)

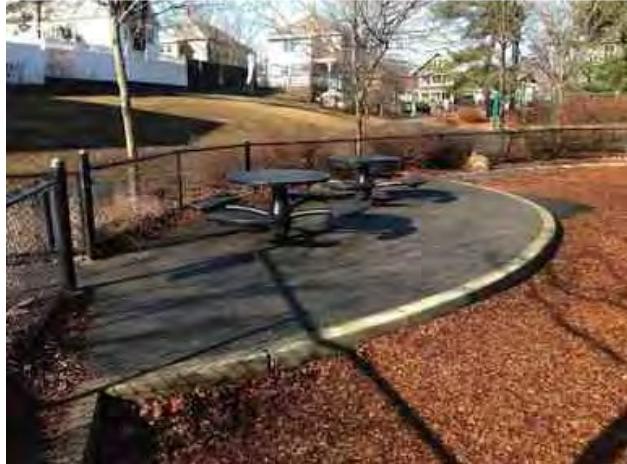
Photo 6

There are two gated entry points to the playground and sitting area (Photo 6) and, there is a gate to the Teel Street Basketball court entry point.

Gates are missing smooth surface or kickplate hardware. Teel St. gate to the basketball courts is not along an accessible route and ground surface is not firm, level and smooth.

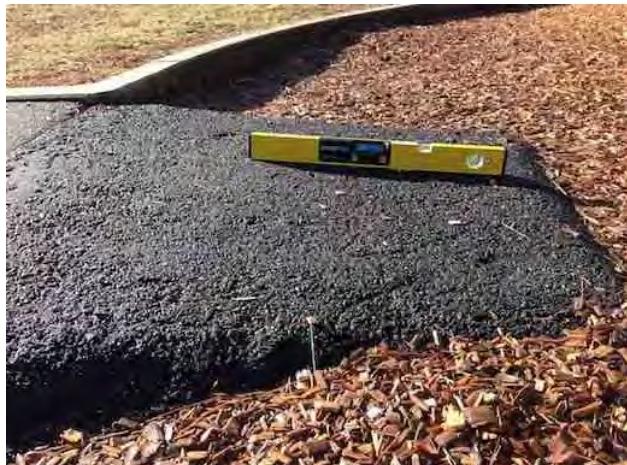
Photo 8

At least one accessible route is not provided within site perimeter to all entry/exit points of play areas, including court, swingsets and playground; and there is no accessible route provided to all entry/exit points of the ground play structures and elements within the play areas. (Photo 9)

Regrade and expand interior circulation paths to provide an accessible route that extends to the swingsets, all ground play elements within playground boundaries, seating areas, signage, and the basketball court.

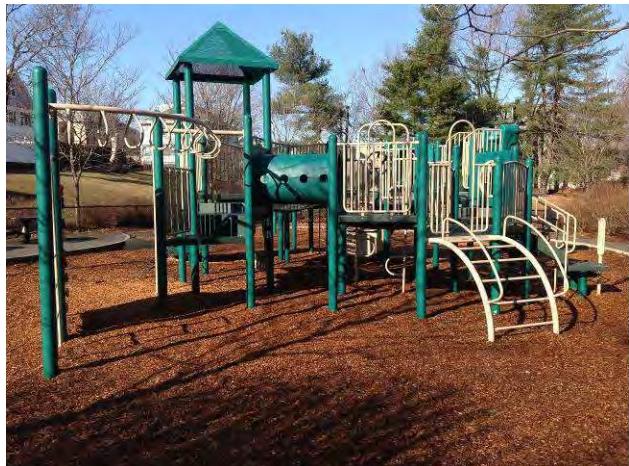
Photo 10

The composite play structure has an excellent variety of accessible ground play elements plus a transfer system which provides access to various types of elevated play elements, including interactive panels, climbing, crawling and swinging play elements. (Photo 10)

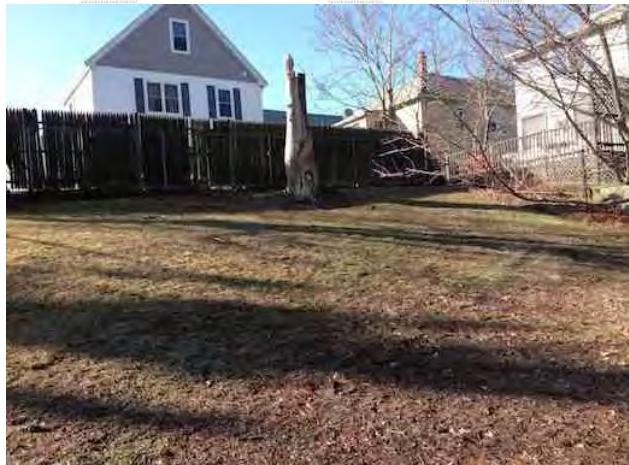
Photo 12

A public art tree sculpture sits on the west hill near the Waldo Road entrance. This art installation has the potential to be a special meeting and socializing area within this Park. If possible, a level-graded path with at least 36 inches width along the west perimeter of the park can be installed for all to approach and enjoy this unique feature. This path can connect with the Teel St. entryway. (Photo 12)

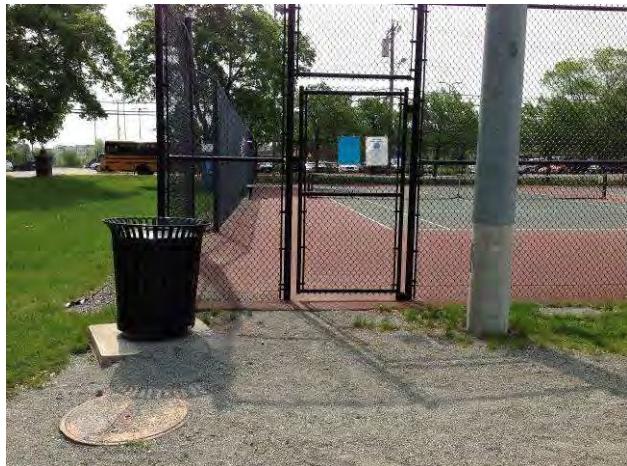
Photo 4

There are two gated entry points to each tennis courts. All gates are missing smooth surface or kickplate hardware. The surface of the two gates adjacent to the gravel walkway on the north edge of the courts is not firm, level and smooth. (Photo 4)

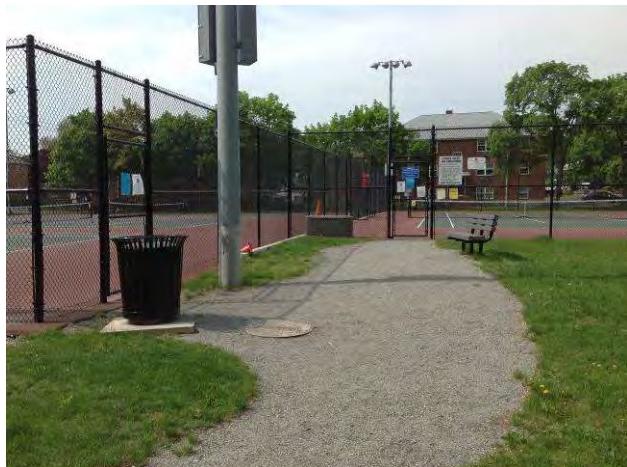
Photo 5

A gravel walkway is provided between the point of entry at the northeast point of the site and the north edge of the tennis courts. Walking surface is not consistently firm, stable or slip-resistant near the tennis courts. (Photo 5)

Repair/compact gravel walkway or replace it with asphalt walkway near the tennis courts (about 50 feet) and extend asphalt walkway from the tennis courts to climbing wall (about 150 feet).

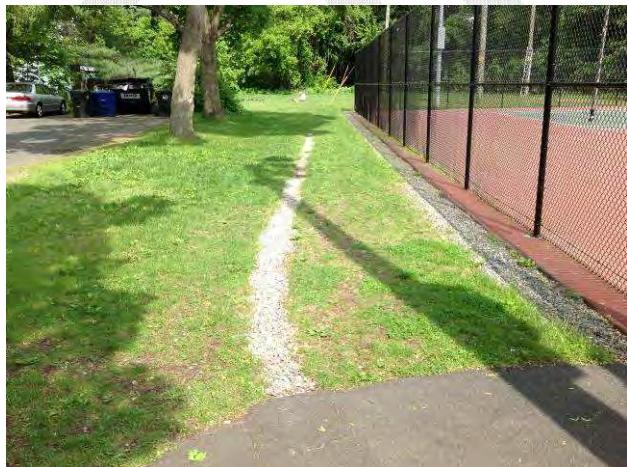
Photo 6

Along the south edge of the tennis courts, an asphalt walkway provides an accessible route between the street and the tennis courts. However, the walkway does not extend beyond the tennis courts and an accessible route is not provided to climbing wall on the west side of the site. (Photo 6)

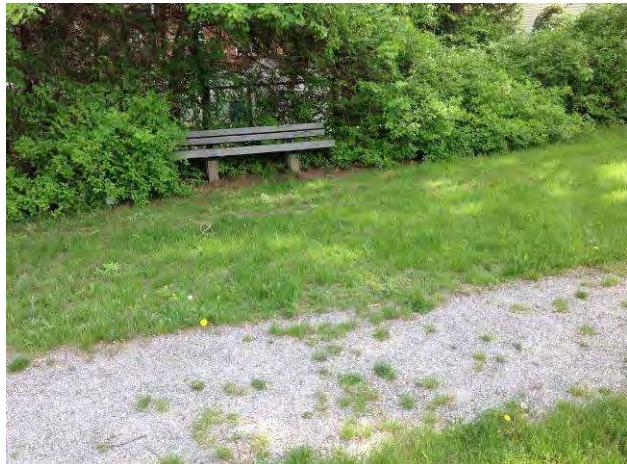
Photo 7

Two benches are provided along the gravel walkway on the north side of the tennis courts. One bench located along the north edge of the site is not inaccessible because it does not adjoin an accessible route. (Photo 7)

Neither bench has armrest nor do they offer integrated shoulder-to-shoulder clear ground space that is firm, level and slip-free for wheelchair seating.

Although not a requirement under the ADA, consider providing at least 50% with armrests, as benches are replaced (total of 2 benches).

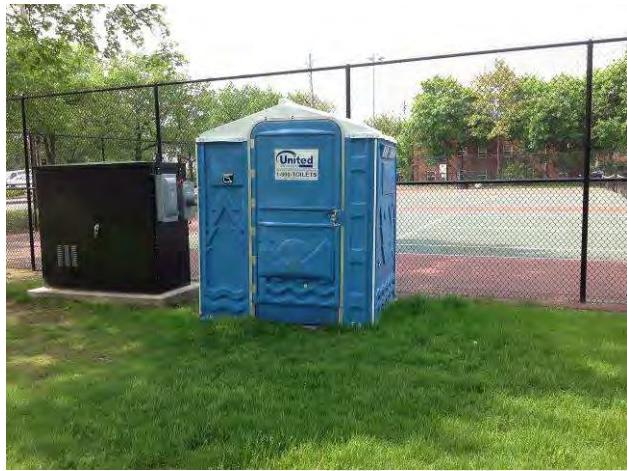
Photo 8

One portable toilet room is designated as accessible and is located along the north edge of the three tennis courts. However, this amenity is not inaccessible because it does not adjoin an accessible route. (Photo 8)
